## GFL Emerald Park Landfill Audit Summary

**TO:** GFL Emerald Park Landfill Standing Committee, City of Muskego  
**FROM:** Jo-Walter Spear, Jr., P.E.  
**COPIES:** File  
**DATE:** 3/1/2021  
**PROJECT NUMBER:** 1012.10030

Attached is the audit report for activities at the GFL Emerald Park Landfill for the week of January 31, 2021. The audit was performed at 12:01 PM on **February 3, 2021** by Jo Spear, Jr.; in the presence of Chad Seigel, the Site Manager.

**ADVANCED DISPOSAL SERVICES  
EMERALD PARK LANDFILL / CITY OF MUSKEGO  
AUDIT PHOTOS**

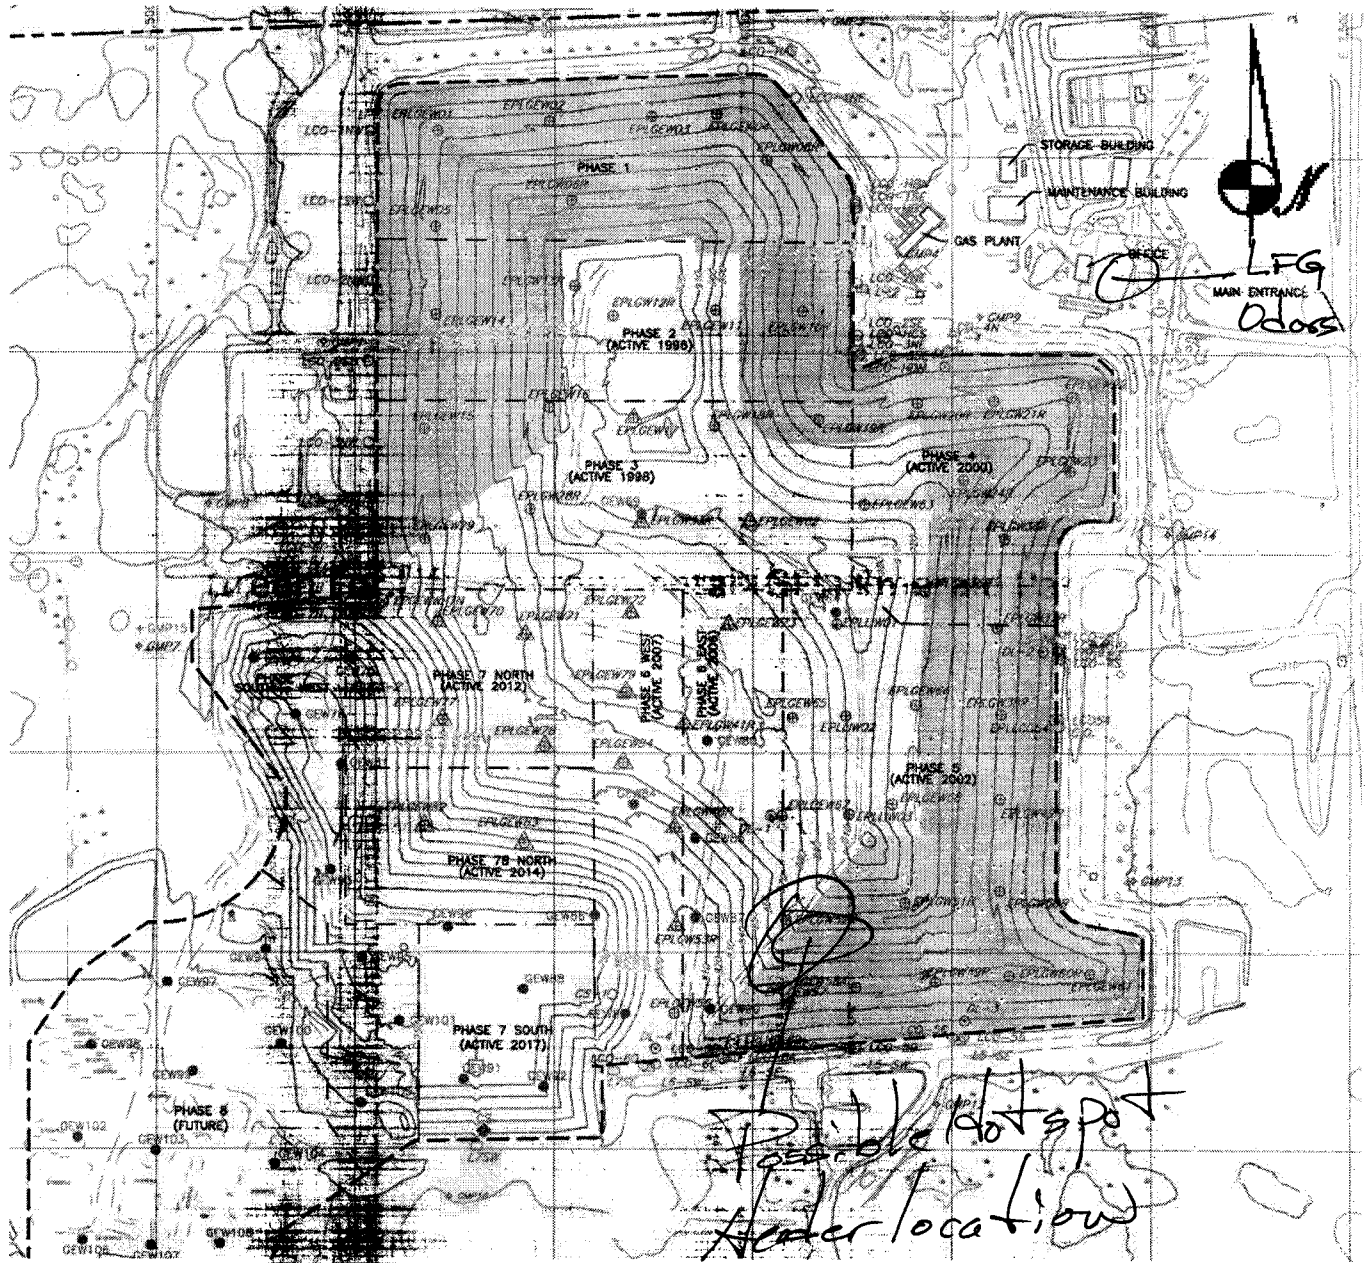
Opposite Odor

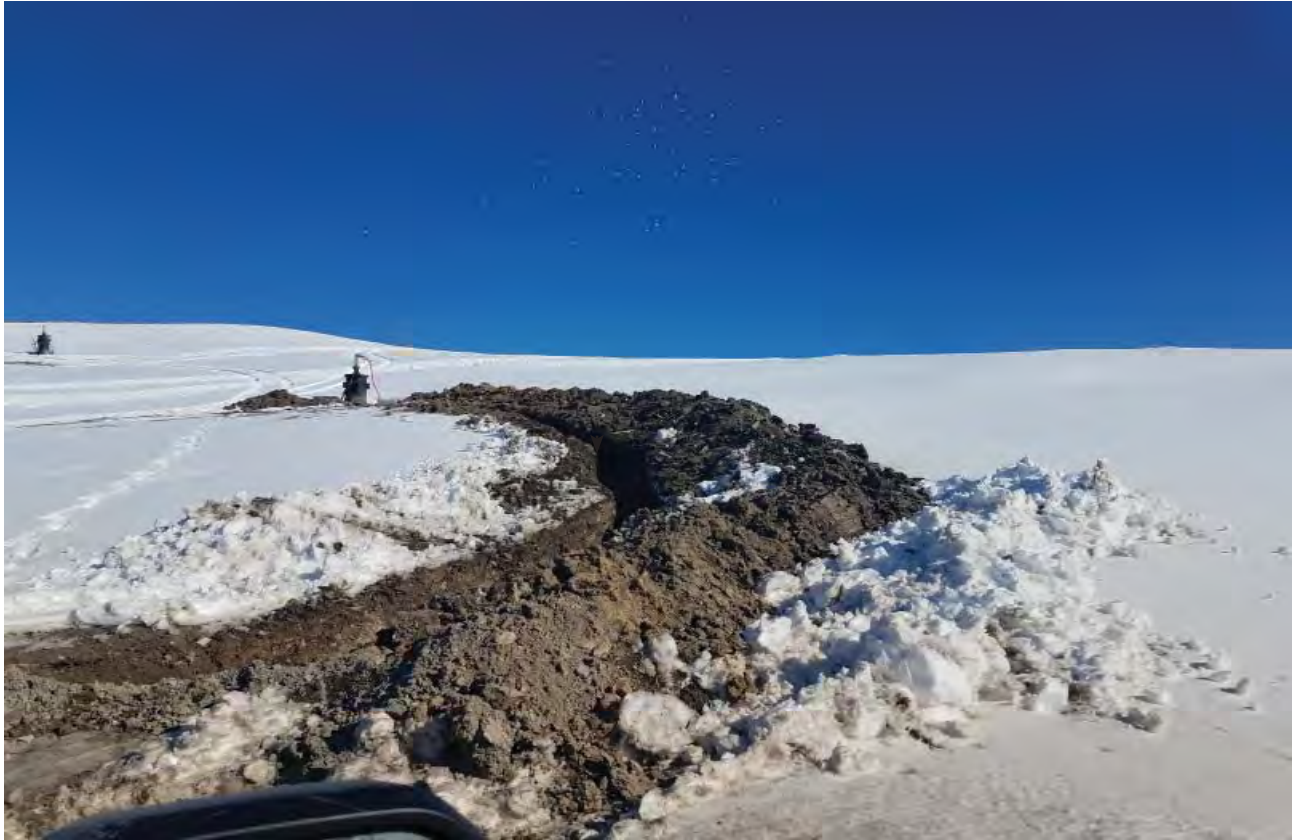
Repair to connections between wells to insure gas containment

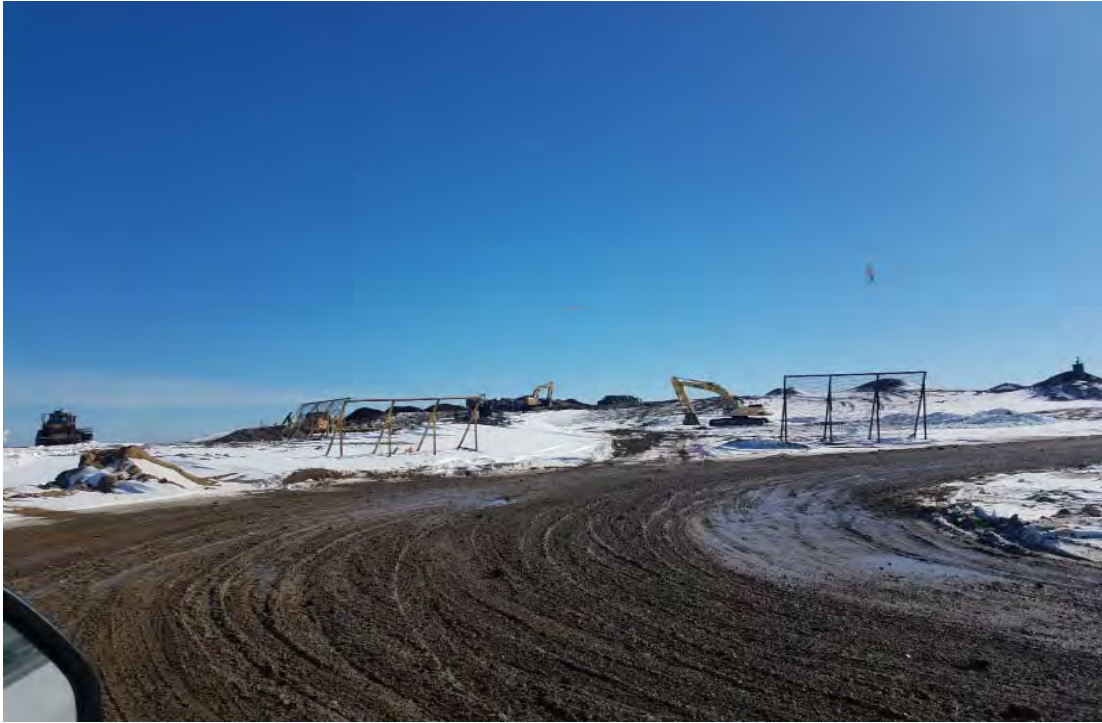
Overview of Phase 7

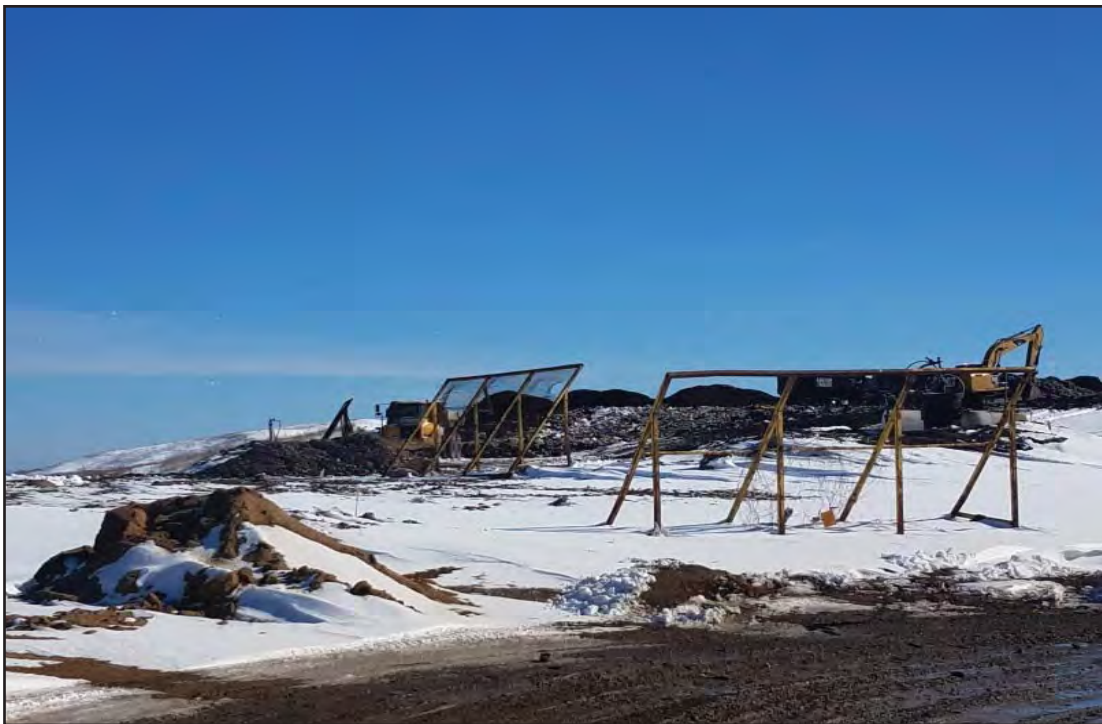
Tipping of trucks in Southeast corner of Phase 7 North

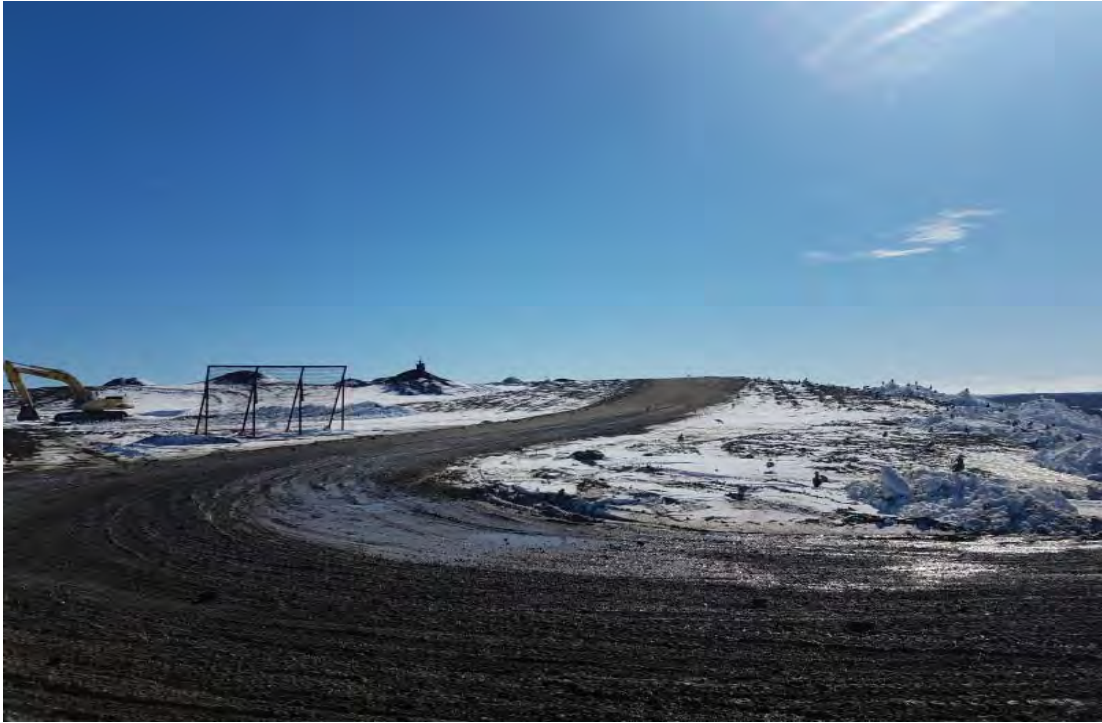
Phase 7, berm about top of Phase to allow waste placement in inclement weather

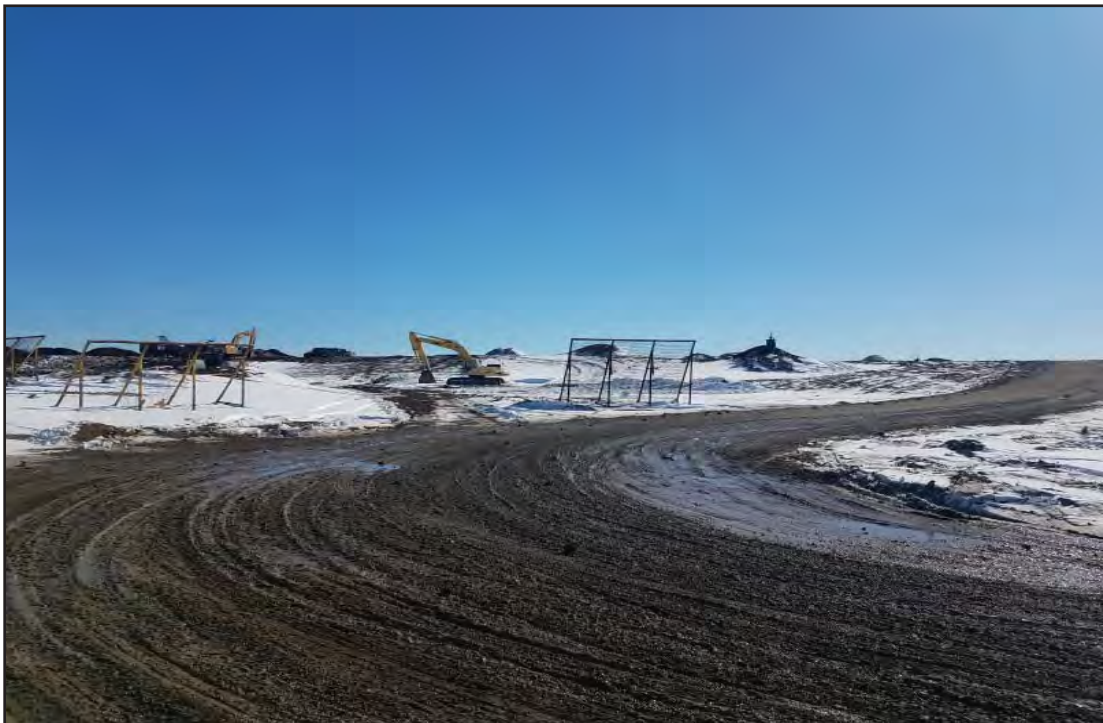
Access into Phase 7

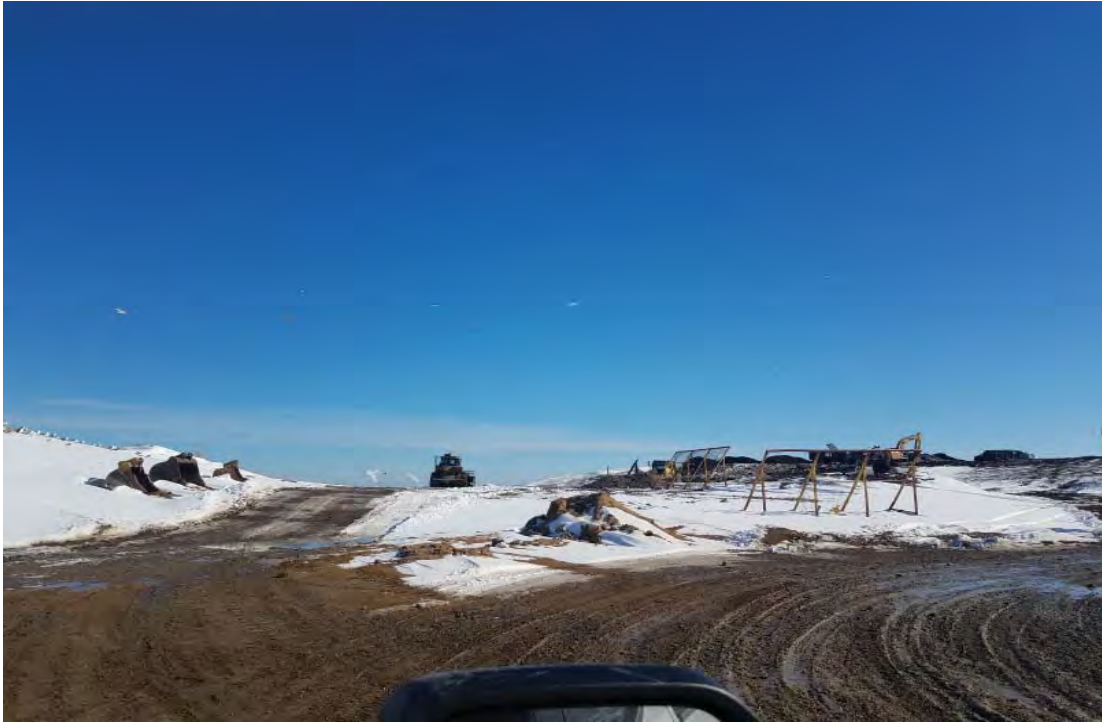
Phase 7 viewed from the Northwest, right hand road goes to working face; left hand road allows access of staff to LFG management wells
