GFL Emerald Park Landfill Audit Summary

TO: GFL Emerald Park Landfill Standing Committee, City of Muskego
FROM: Jo-Walter Spear, Jr., P.E.
COPIES: File
DATE: 3/12/2021
PROJECT NUMBER: 1012.10030

**ADVANCED DISPOSAL SERVICES
EMERALD PARK LANDFILL / CITY OF MUSKEGO
AUDIT PHOTOS**

PROJECT NO. 1012.10030

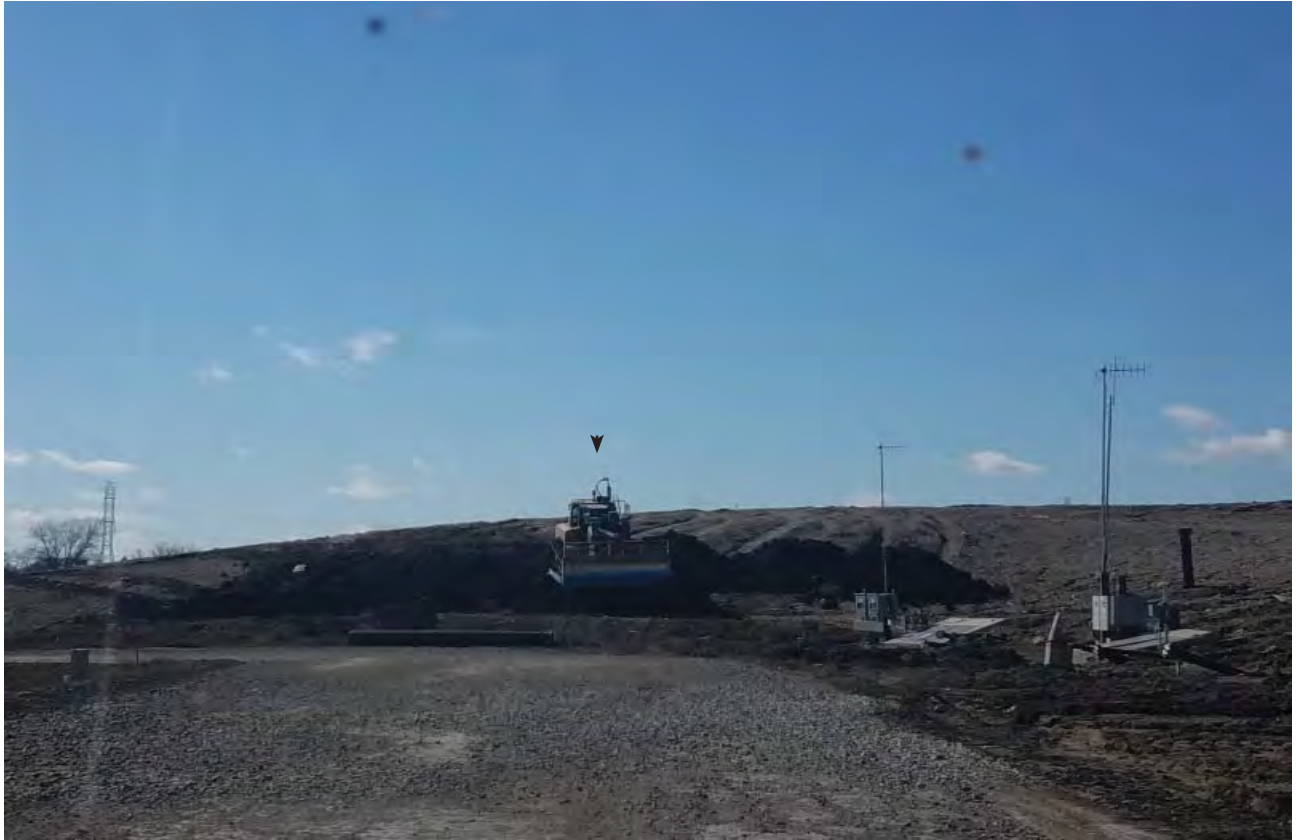
- Offsite liter is a product of snow melt and not “new” litter
 - A berm is under construction in the Southwest corner of Phase 7 South at bottom of the slope to disperse and slow runoff and reduce erosion.

* Berm construction at toe of
Phase 7, South slope in Southwest
corner to slow runoff velocities
and reduce erosion

South slope of Phase 7. Berm being placed to control and slow runoff from upper slopes.

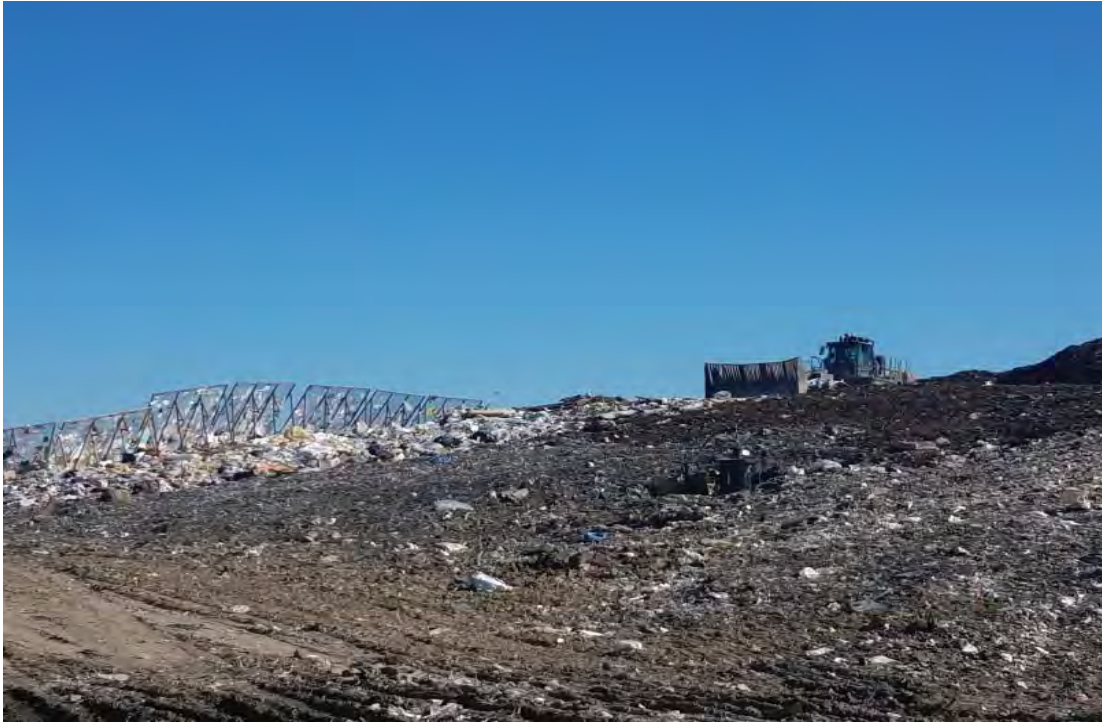
Working face with mobile fencing to catch litter on a high wind day

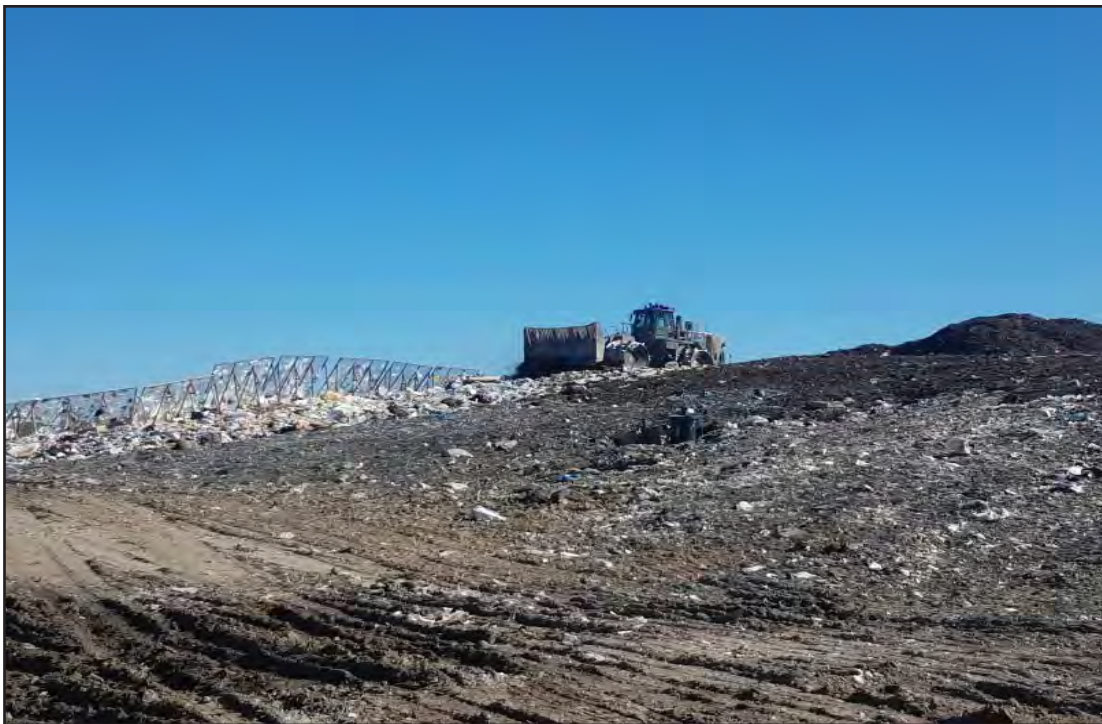
Working face at East edge of Phase 7, bare edge of slope.

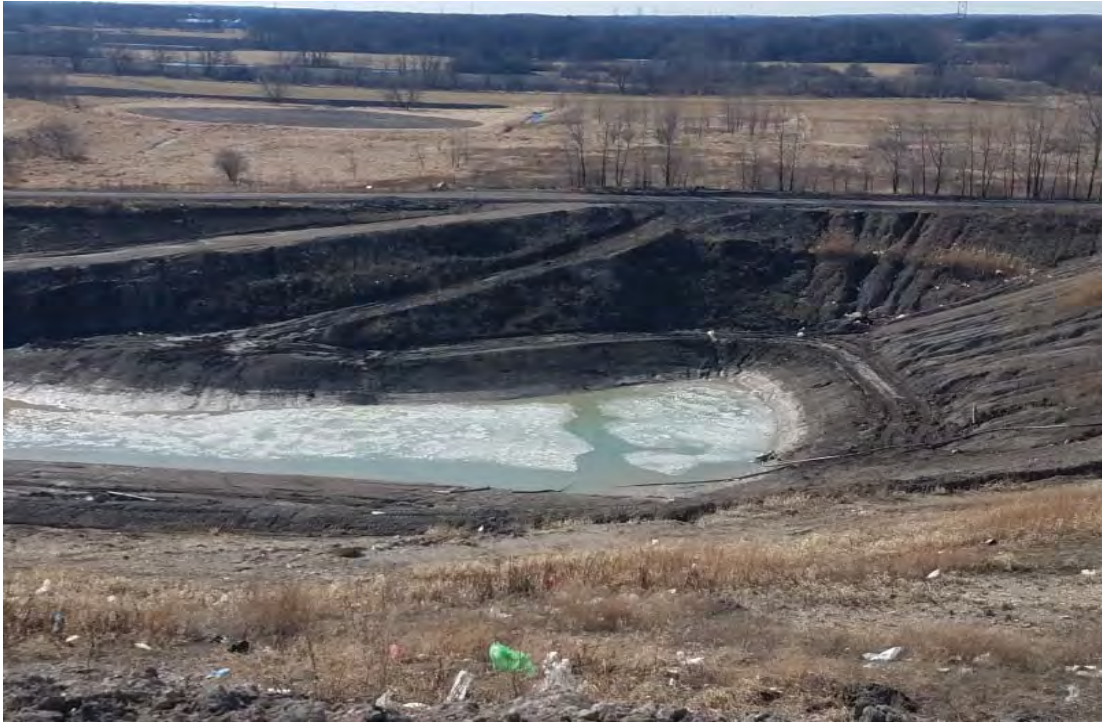
Temp sed basin, pump is placed and the basin is well emptied

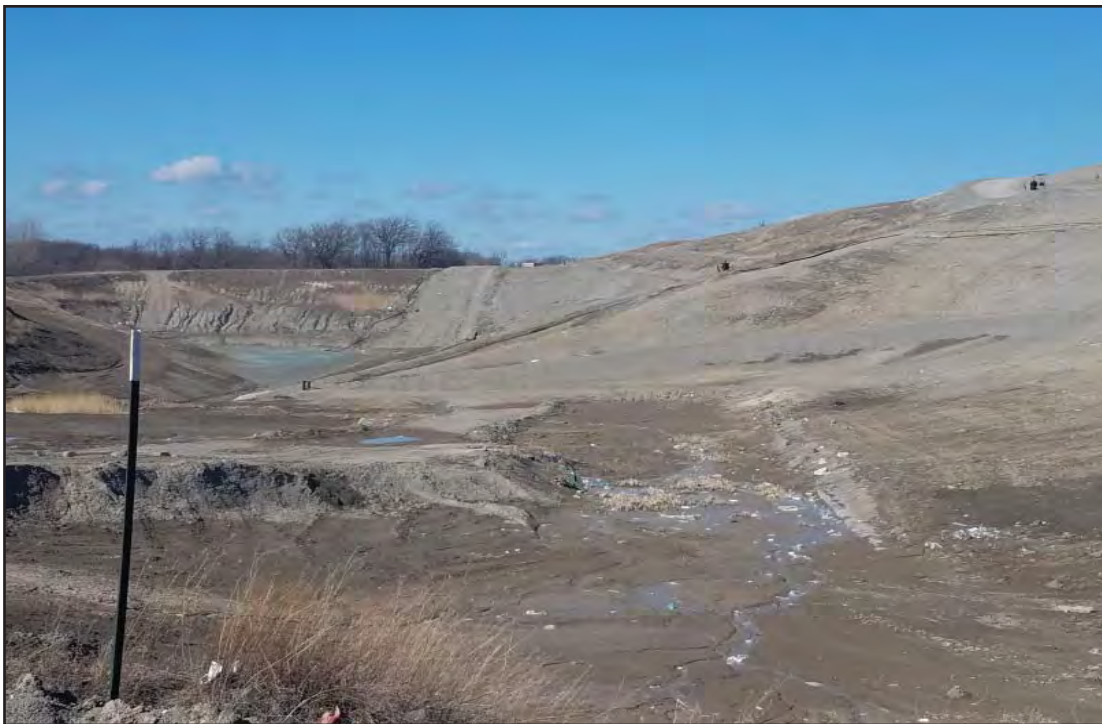
West slopes of Phase 7, temp sed basin in the far end of picture
